SUBJECT: Site Inspection, Diamond K Gypsum, DKG Quarry, M/015/041, Emery County, Utah

Date of Inspection: July 2, 2004  
Time of Inspection: 8:45 to 10:15 a.m.  
Conditions: Clear, 80's  
Participants: Bill Price and Adam Parsons, Diamond K; Paul Baker, DOGM

**M/015/041, DKG Quarry, Diamond K Gypsum**

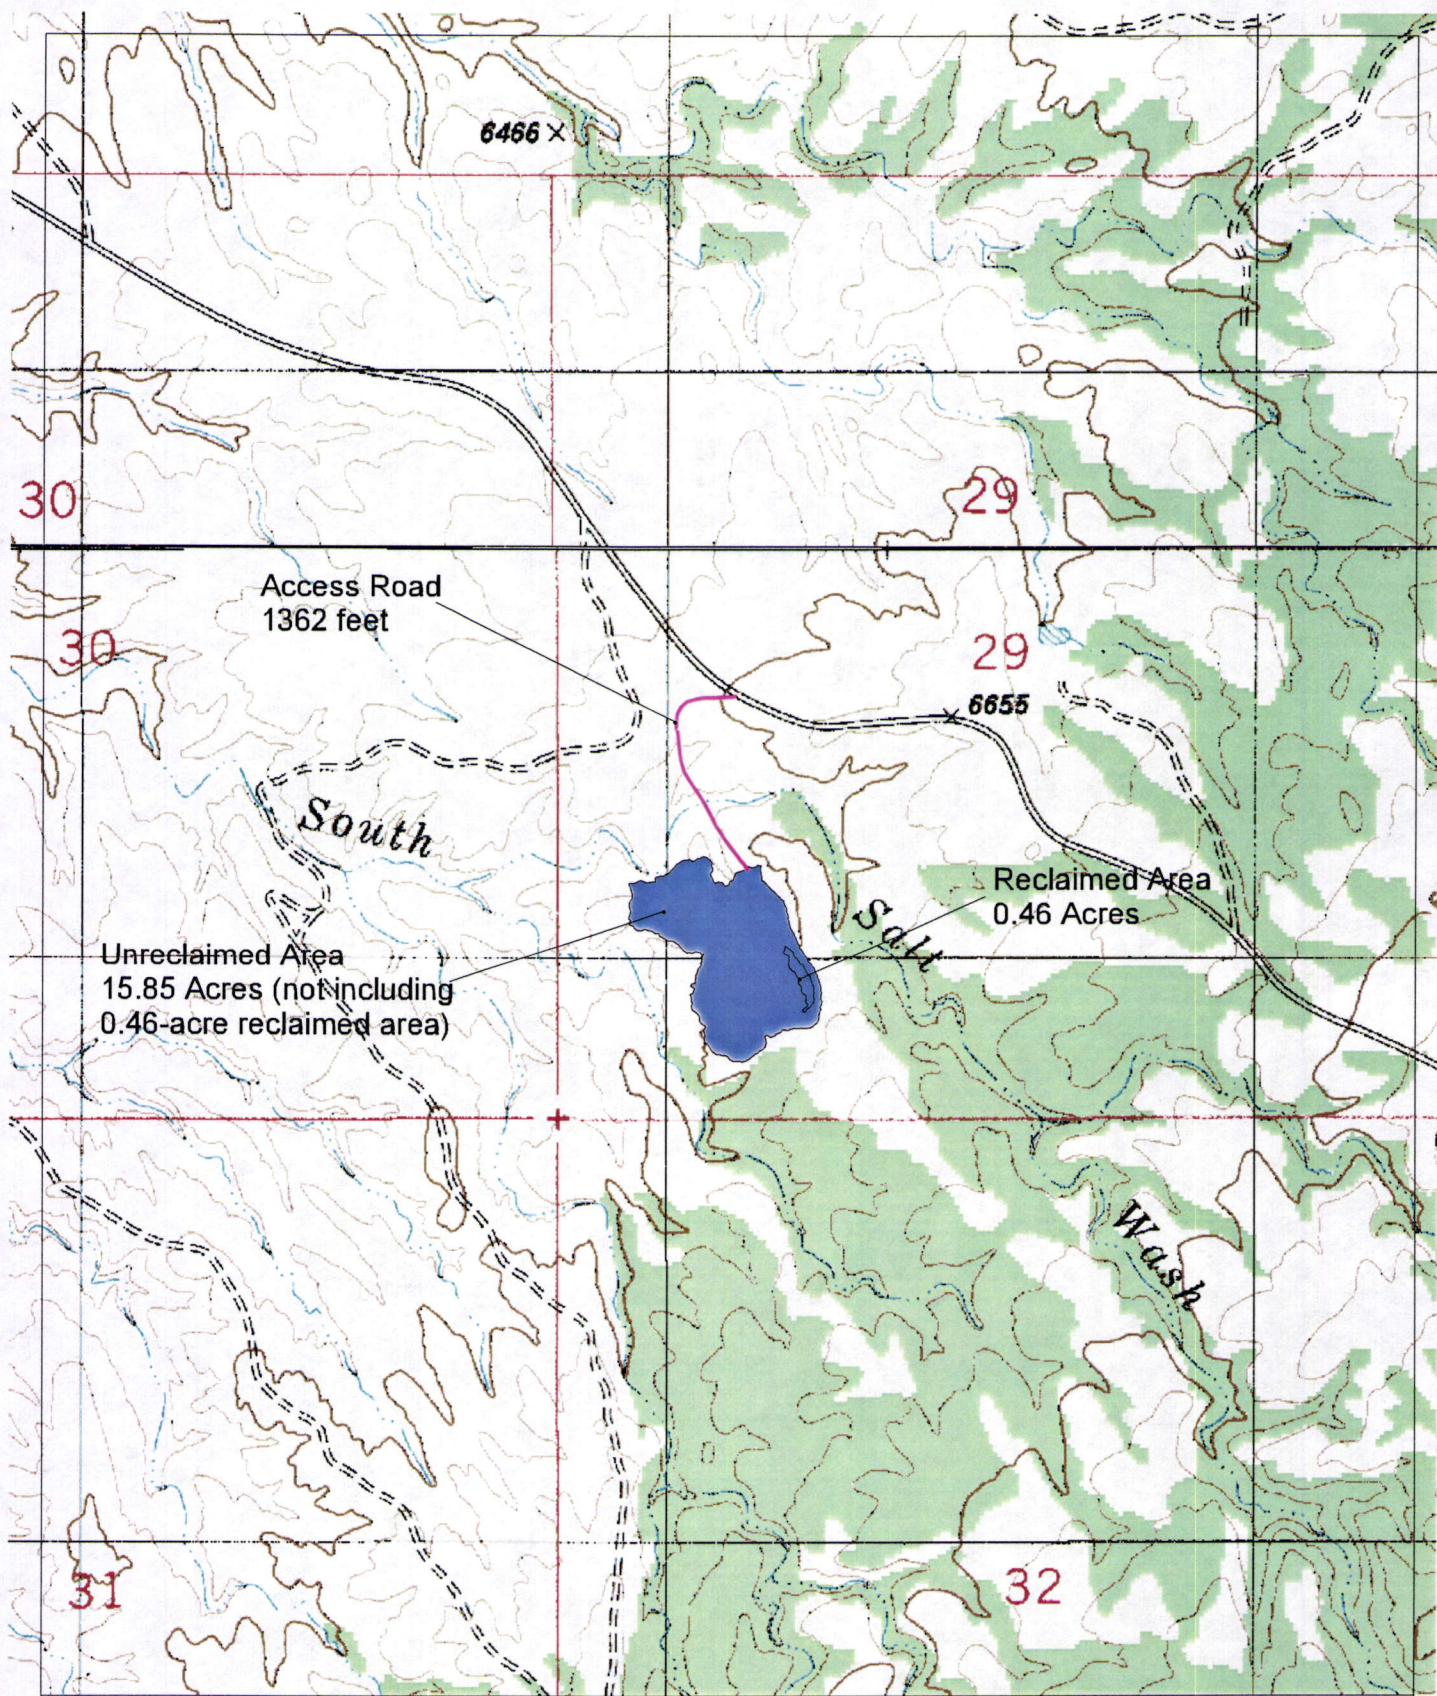
A map showing the areas measured with the GPS is attached to this report. It shows the active disturbance as 15.85 acres. According to the mining and reclamation plan, the road would also be reclaimed, but it appears the first 308 feet of road existed prior to the mine and should not be reclaimed. The road was

1362 feet long, so subtracting the area that would probably not be reclaimed and multiplying by the width I estimated (35 feet), gives 36,890 square feet or 0.85 acres. Adding this to the disturbed area for the mine itself gives a total disturbed area acreage of 16.70 acres, not counting those areas that have been regraded and seeded.

The reclamation contract says a maximum of 12.6 acres of land will be disturbed at any one time. Since the actual disturbed area is 16.7 acres, the operator needs to reclaim at least 4.1 acres of land as soon as possible. Alternatively, the operator could post additional bond to cover this additional disturbance. The current bond is about \$2627 per acre, so the additional bond required would be about \$10,771.

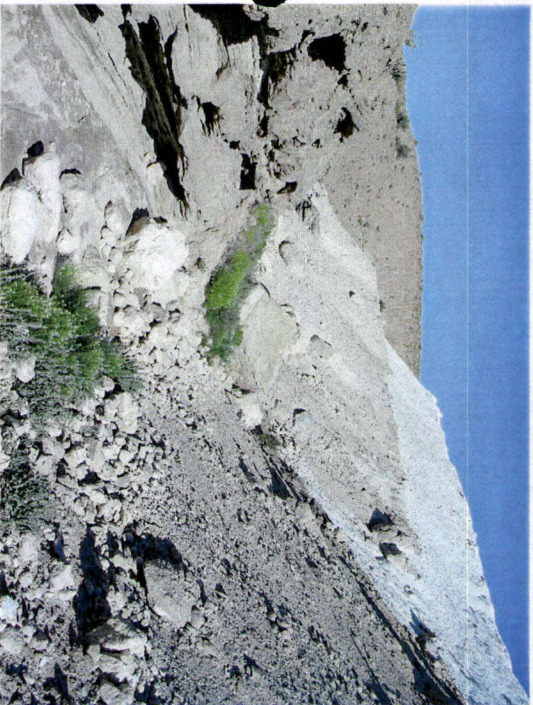
Photos 1 and 3 show where material has gone into some of the adjacent ephemeral drainages. I had some concern about this getting into the runoff, but I did not see evidence of much, if any, sediment leaving the site.

**Photo 1. The outslope of one of the mining areas.**

The Division and the operator should watch the drainages for signs that sediment from the mine is being transported off site. If so, it may be necessary to install silt fences downstream, but I do not anticipate this.

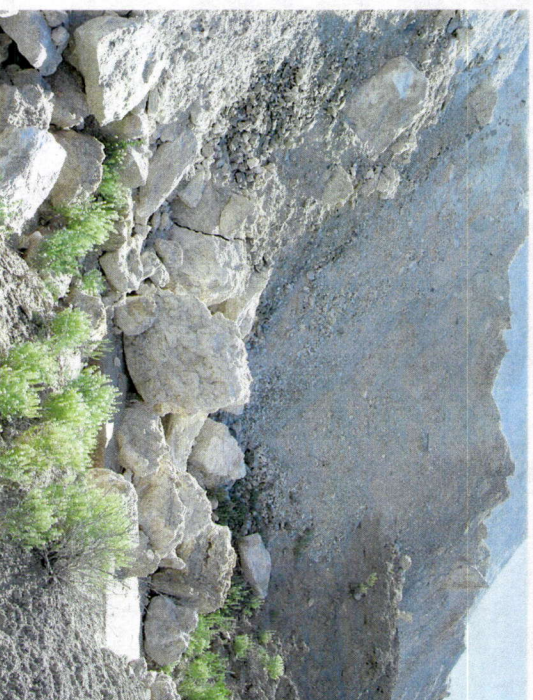
**Photo 3. Another view of an outslope with quite a lot of rock in the drainage.**

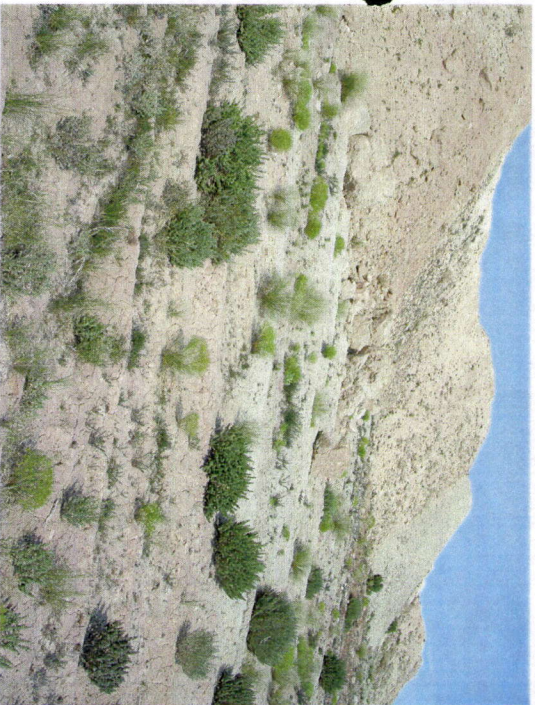
I don't know whether the area on the map marked reclaimed was intentionally reclaimed and seeded or if the plants are the result of natural invasion. This area is shown in Photos 2 and 4. Most of this area had a fair amount of cover from rocks, but some did not.

**Photo 2. A view of a reclaimed area within the disturbed area.  
Note the amount of native vegetation.**

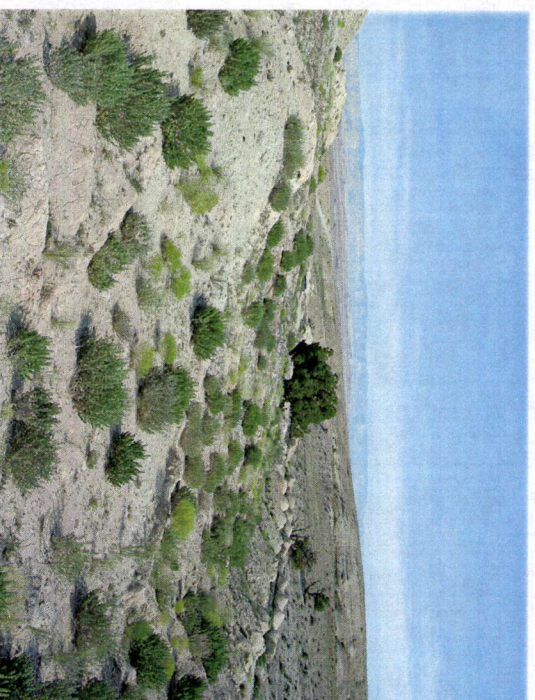
**Photo 4. The reclaimed area.**
